# Rosebud County

## HIGH HAZARD LOCATION STUDY

Robert Peccia &  
Associates

December 1982

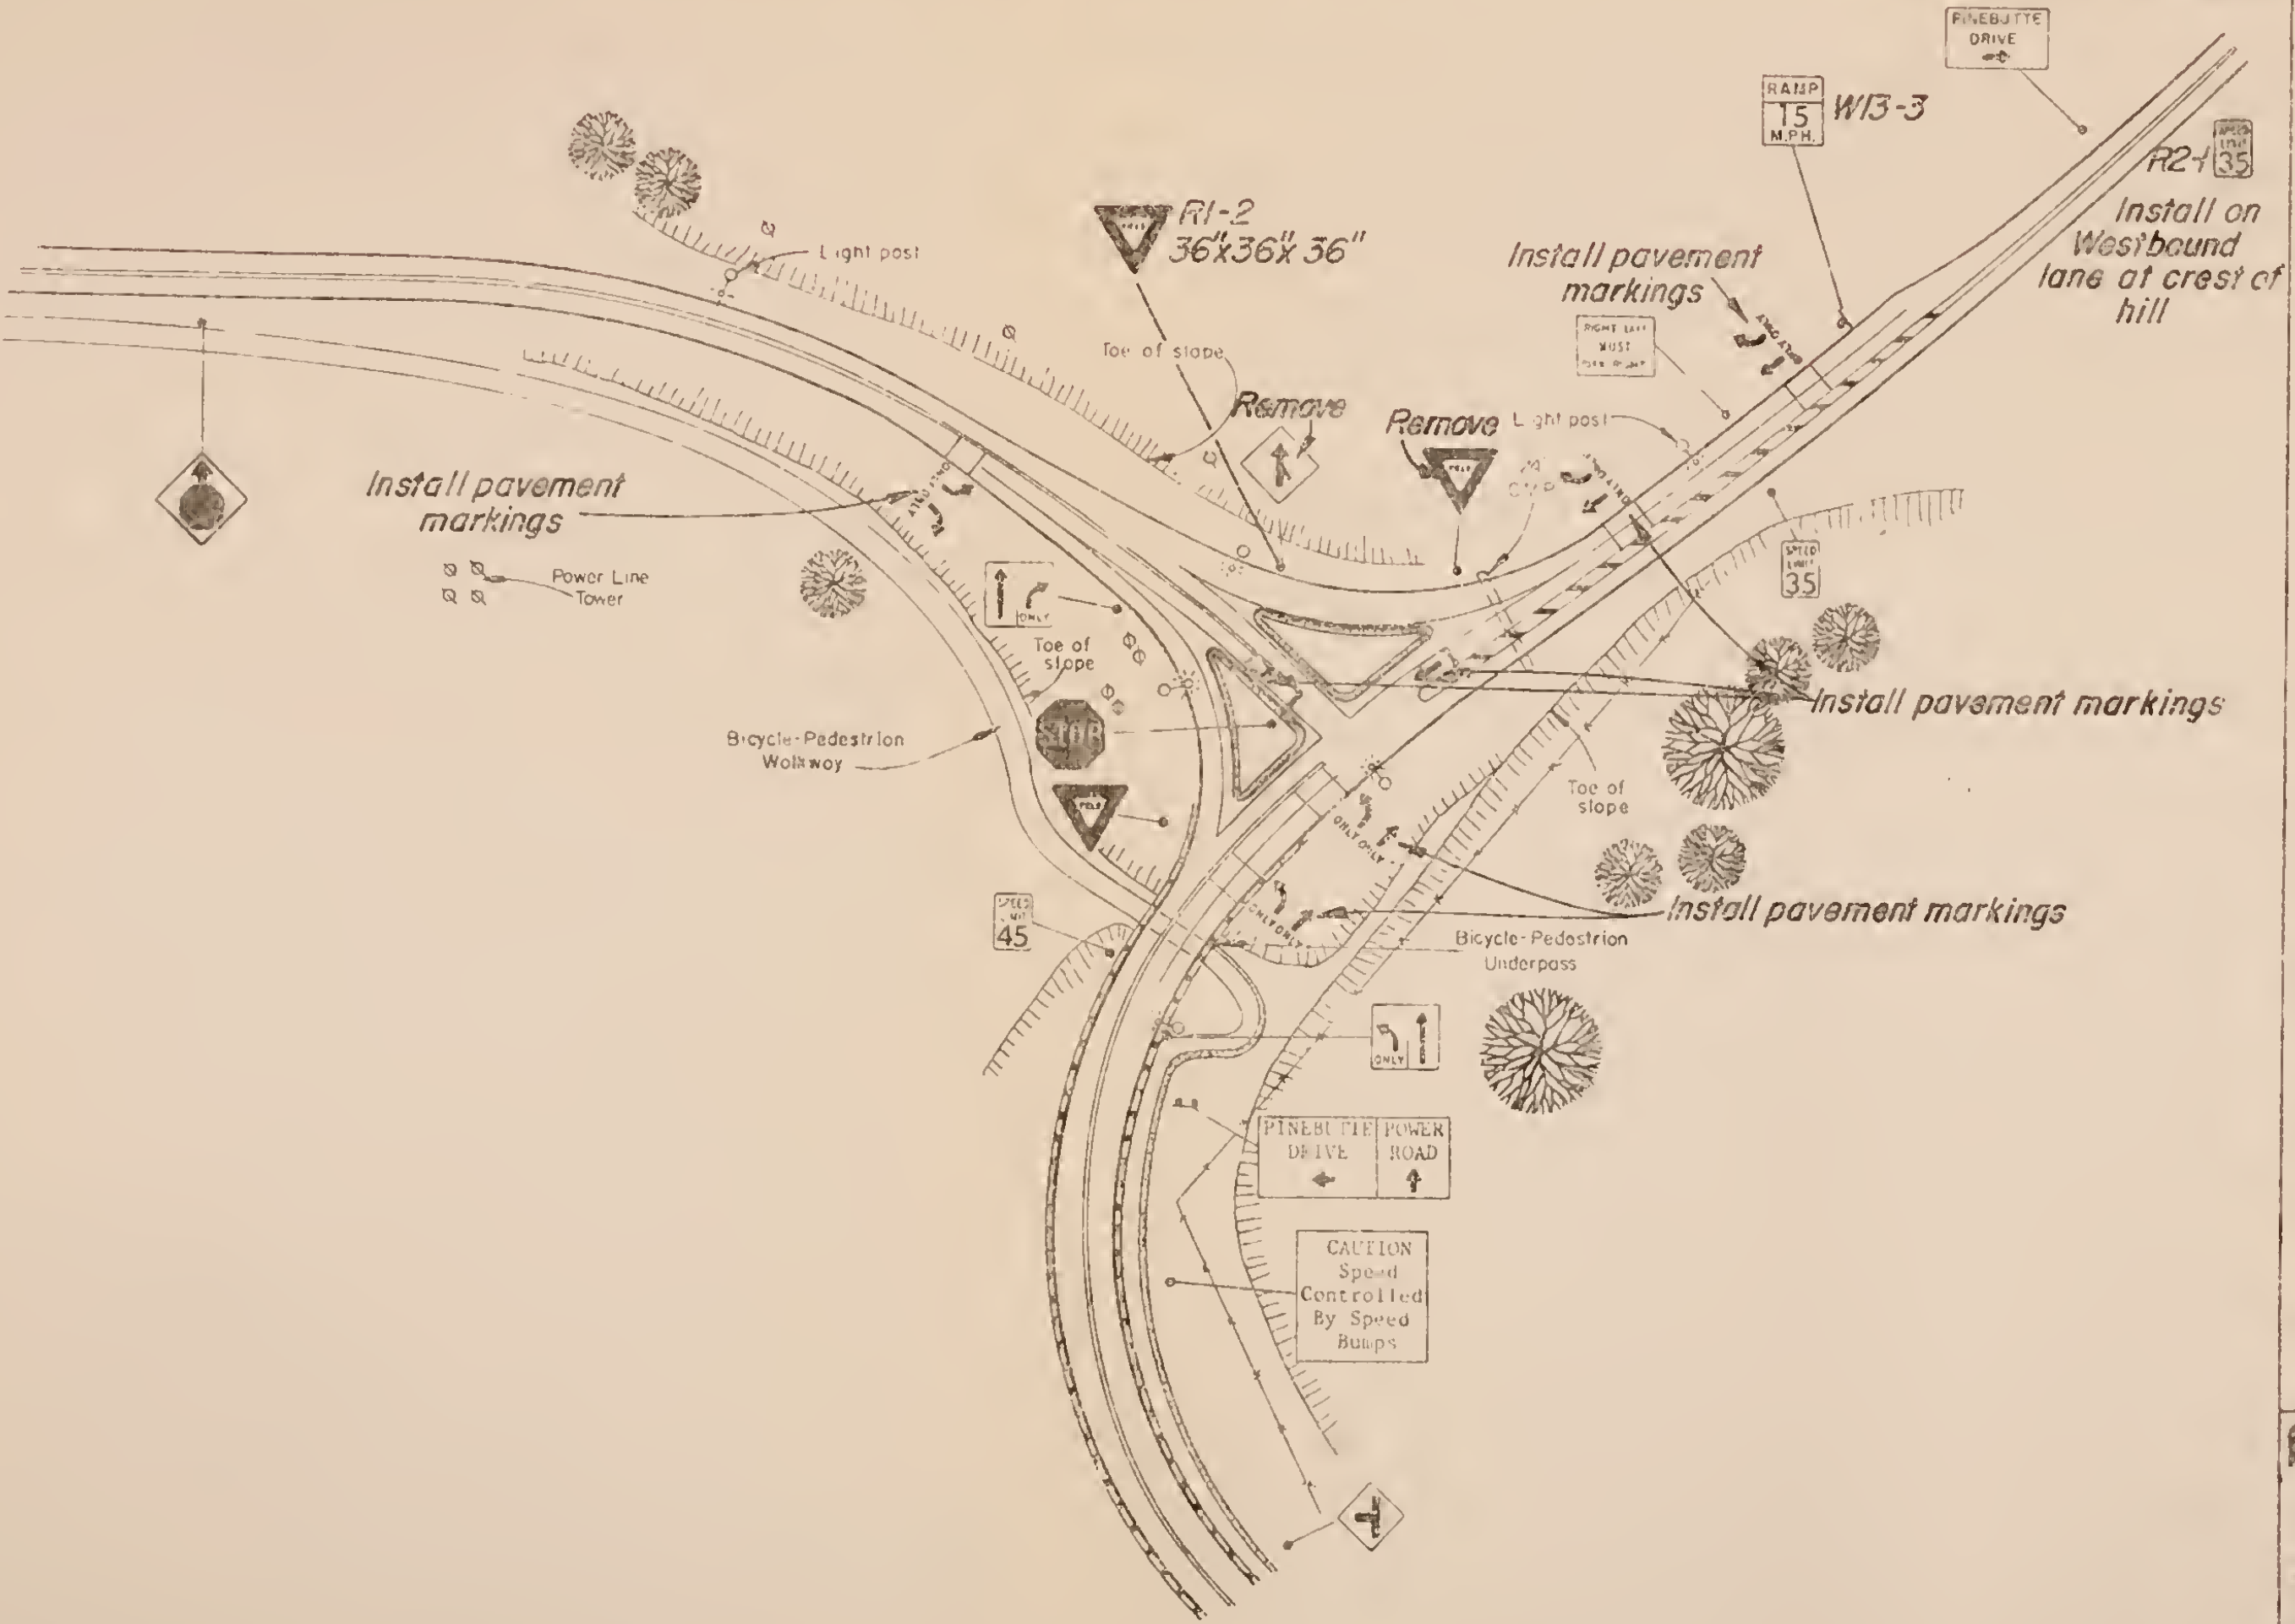
Site No. 4

RECOMMENDED IMPROVEMENTS
